# Safety Inspection Report

Annual Inspection

## Hullbridge Road

Site name: **Hullbridge Road**  
Date of inspection: **20 May 2025**  
Inspector: **Craig Owen**  
[w3w.co/replying.cursing.inflamed](https://w3w.co/replying.cursing.inflamed)

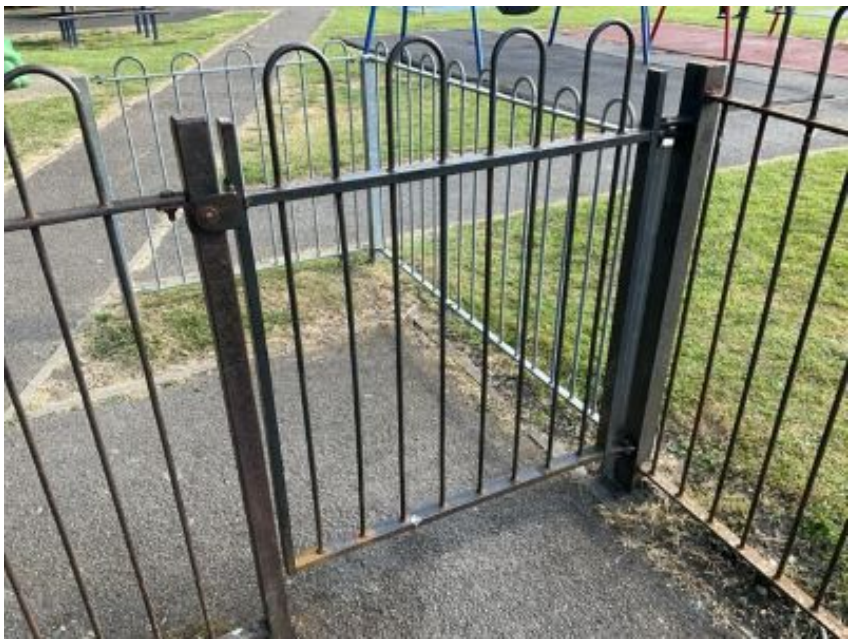
| Welds are cracked. |
| Welds are cracked on the base of brown gate. |

| Repair. |

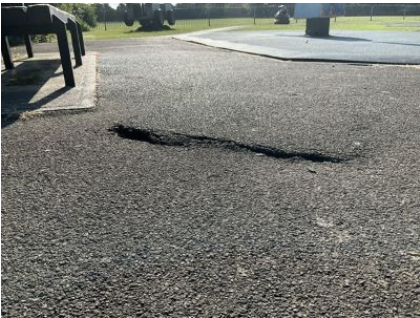
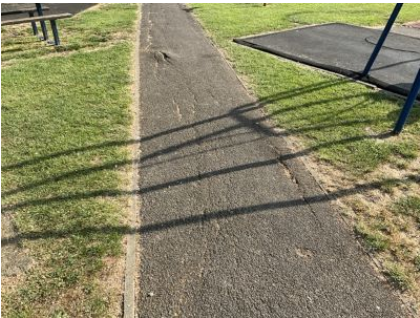
| Description |
|---|
| The surface is cracking. |
| Tree root damage to the path, leaving a trip hazard. |

| Description |
|---|
| Repair. |

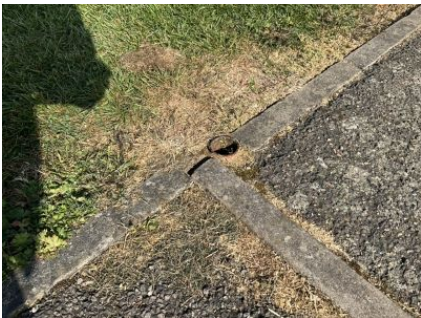
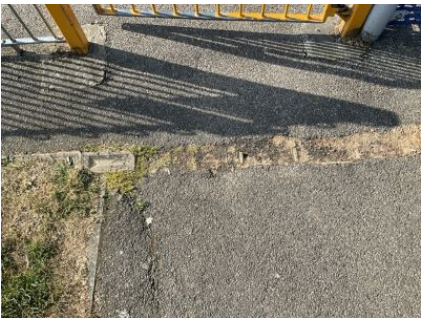
Surface needs repair.

Brick work at field entrance is poor. Repair.  
Raised poles around pathway (near bear bin and jeep). Repair.

Repair.

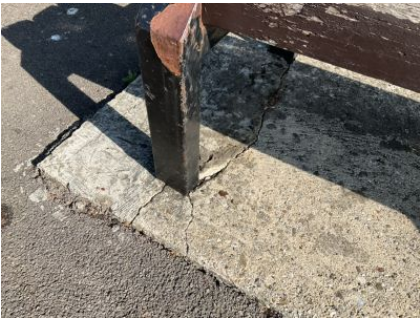
| Description |
|---|
| Concrete edges are in poor condition. |
| Damaged and cracked. |

| Description |
|---|
| Repair. |

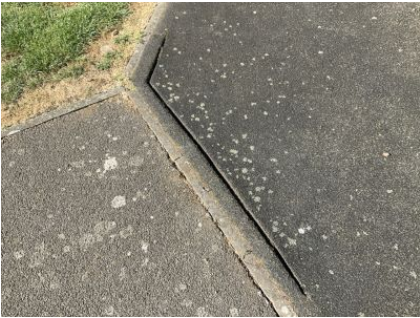
Shrinkage / separation of the surface. This may give a trip hazard.

Wet pour edges are shrinking and lifting, creating a potential trip point/ankle turn. Repair.

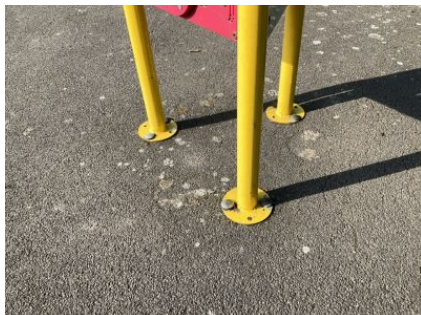
Bolt(s) loose.

Foundation bolts are loosening. Monitor and repair when necessary.

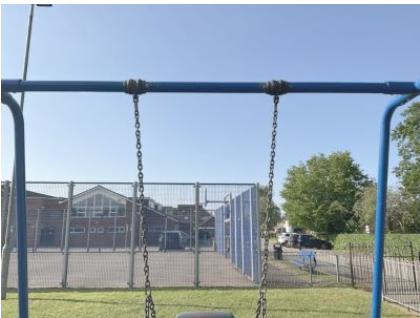
There is wear in the bushes.

Remove shackle bolt and check bush and shackle pin wear, replacing as necessary.

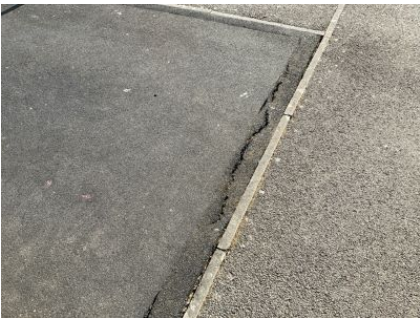
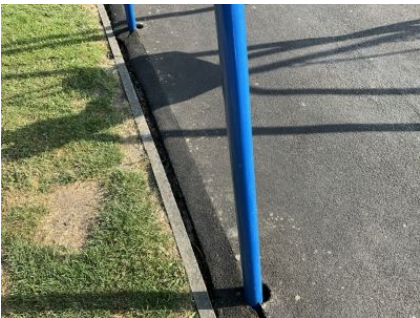
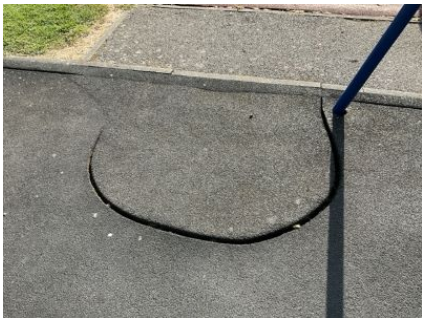
Shrinkage / separation of the surface. This may give a trip hazard.

Wet pour edges are shrinking, cracking and lifting, creating a potential trip point/ankle turn. Repair.

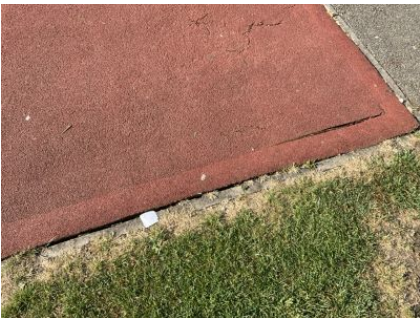
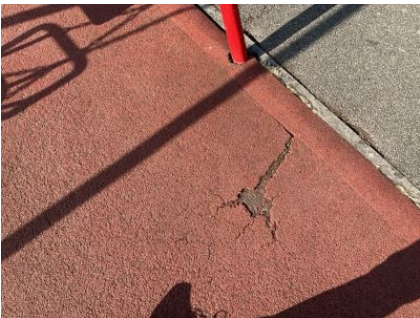
Shrinkage / separation of the surface. This may give a trip hazard.

Wet pour edges are shrinking, cracking and lifting, creating a potential trip point/ankle turn. Repair.

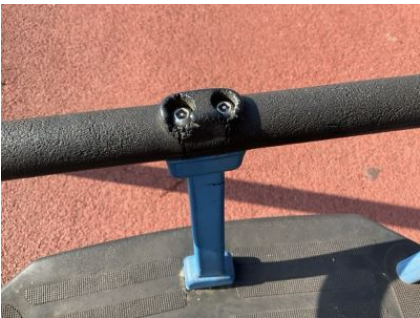
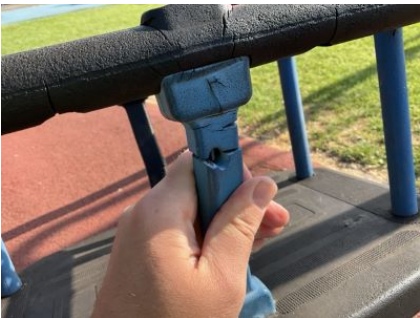
There is wear to the top of the cradle(s) leaving exposed metal.

Rubbers are cracking and deteriorating. Replace when the metal frame is exposed.

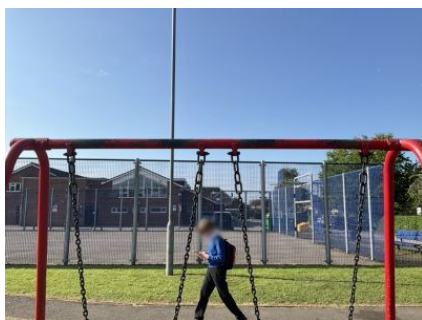
There is wear in the bushes.

Remove shackle bolt and check bush and shackle pin wear, replacing as necessary.

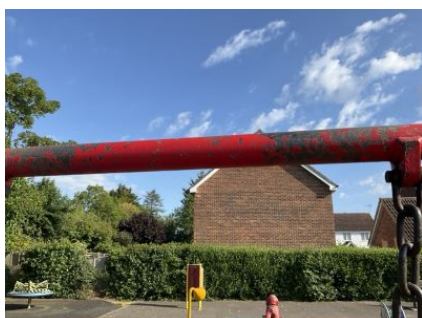
Paintwork is in poor condition.

De-scale back to good base material and coat with lead free paint, using appropriate precautions. Repairs may be necessary where corrosion is severe.

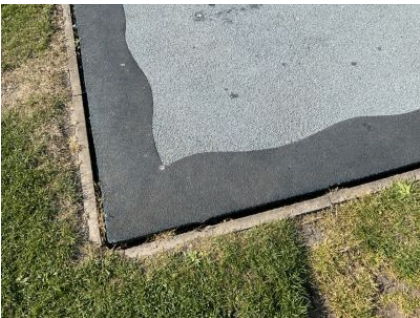
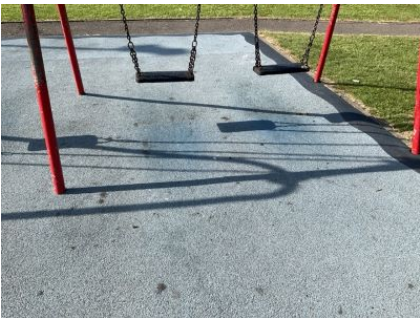
Shrinkage / separation of the surface. This may give a trip hazard.

Wet pour edges are shrinking and lifting, creating a potential trip point/ankle turn.  
Repair.  
Surface drag present underneath seats. Increase height if necessary.

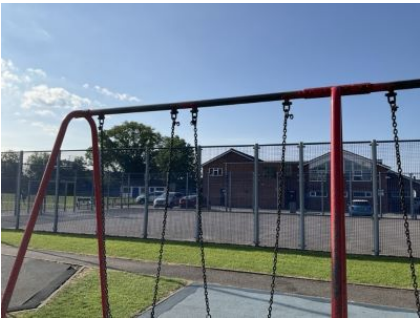
There is wear in the bushes.

Several bushes are wearing. Replace in the near future.

Remove shackle bolt and check bush and shackle pin wear, replacing as necessary.

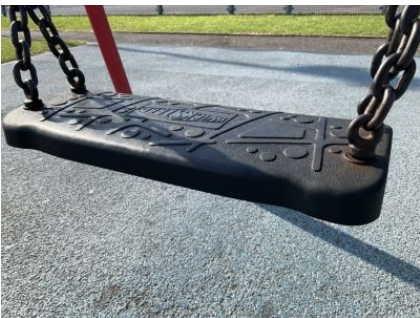
Loose swing seat eye-bolts.

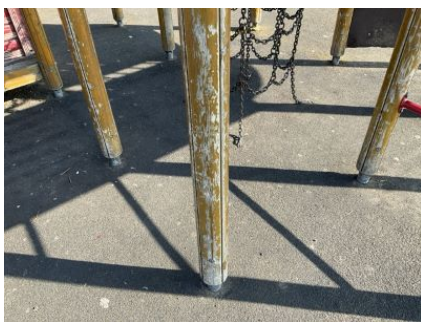
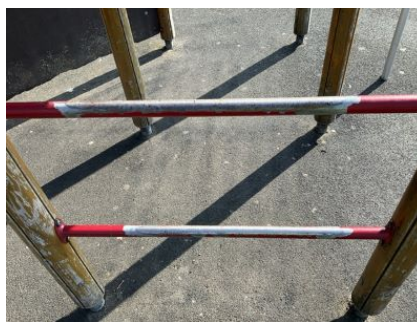
Paintwork is in poor condition.

De-scale back to good base material and coat with lead free paint, using appropriate precautions. Repairs may be necessary where corrosion is severe.

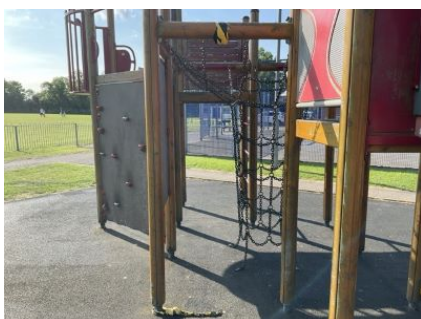
Item is damaged.

Button seat/climbing element is now broken and tapped up to unit. Replace.

Replace.

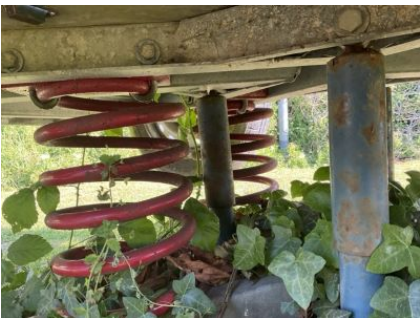
The spring is rusty. These have been known to fail without warning, leading to a collapse of the unit.

Early signs of rusting on spring and suspension.

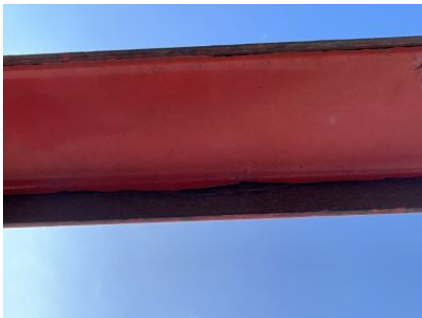
Paintwork is in poor condition.

De-scale back to good base material and coat with lead free paint, using appropriate precautions. Repairs may be necessary where corrosion is severe.

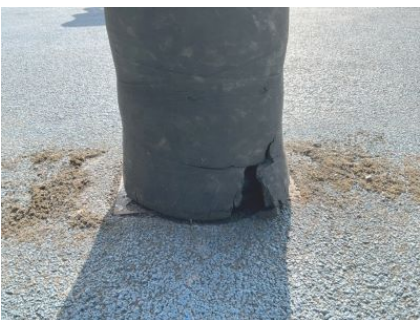
Missing / damaged spring cover.

Replace when necessary.

Replace.

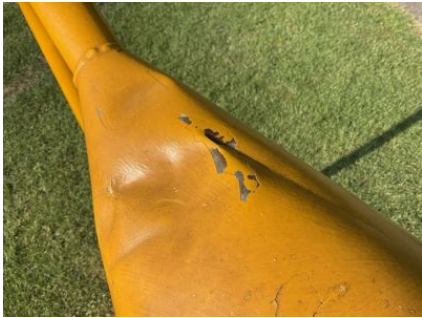
Additional comments are noted below.

Dented. Monitor.  
Chipped paint. Repaint.  
Worn ground areas. Repair.

Monitor., Repair.

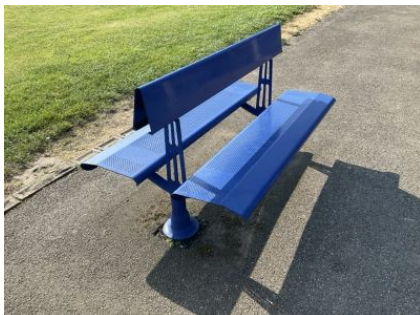
Bolt(s) loose.

Muga benches are loose to surface. Repair.
