# Safety Inspection Report

Annual Inspection

## Hullbridge Road

South Woodham Ferrers Town Council

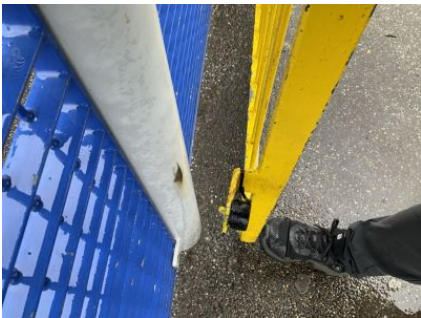
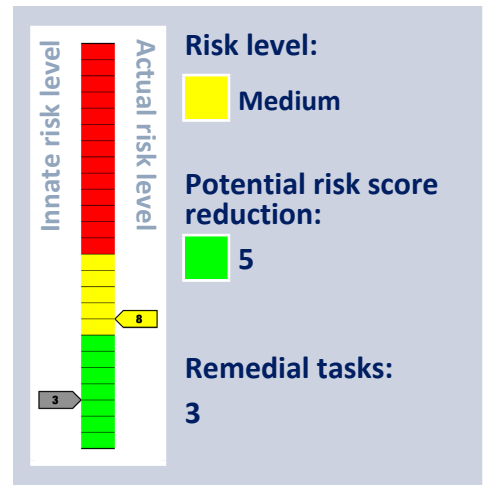
| Description |
|---|
| Welds are cracked. |
| Welds are cracked on the base of brown gate. |

| Description |
|---|
| Repair. |

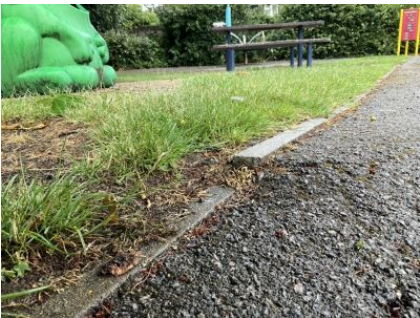
Surface needs repair.

Repair.

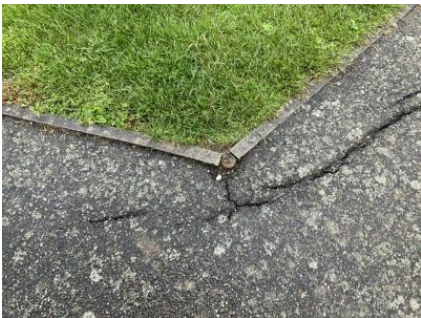
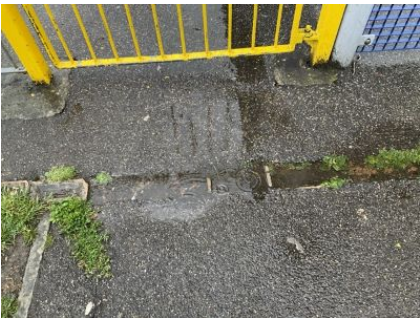
Surface needs repair.

Brick work at field entrance is poor. Repair.  
Raised poles around pathway (near bear bin and jeep). Repair.

Repair.

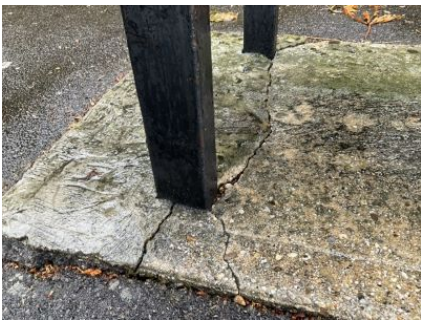
| Description |
|---|
| Concrete edges are in poor condition. |
| Damaged and cracked. |

| Description |
|---|
| Repair. |

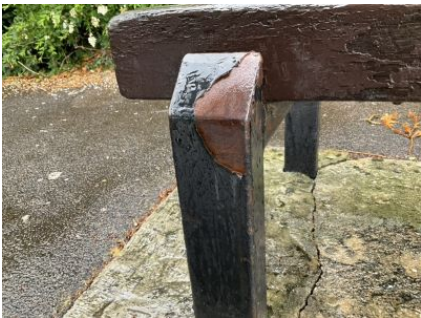
Paintwork is in poor condition.

De-scale back to good base material and coat with lead free paint, using appropriate precautions. Repairs may be necessary where corrosion is severe.

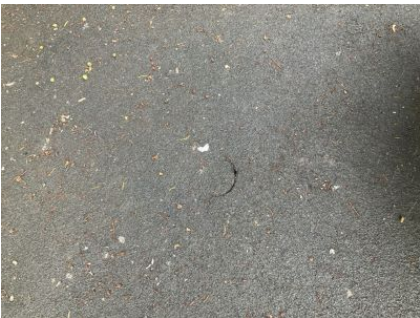
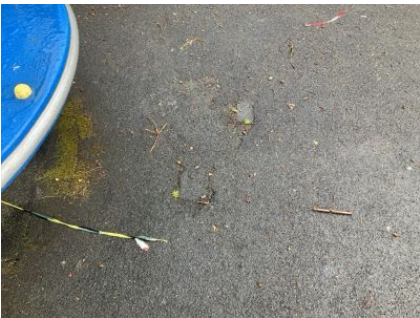
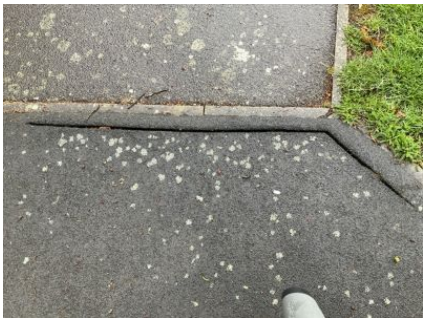
Surface needs repair.

Wet pour edges are shrinking and lifting, creating a potential trip point/ankle turn.  
Repair.  
Cracking and worn areas. Repair.

Re-glue and fill gaps and joints as necessary., Repair.

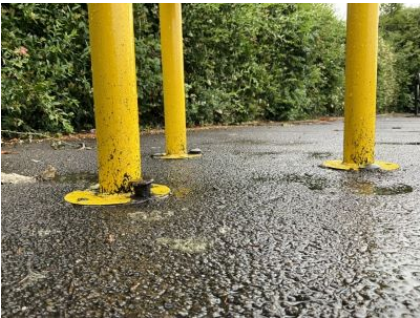
Bolt(s) loose.

Foundation bolts are loosening. Monitor and repair when necessary.

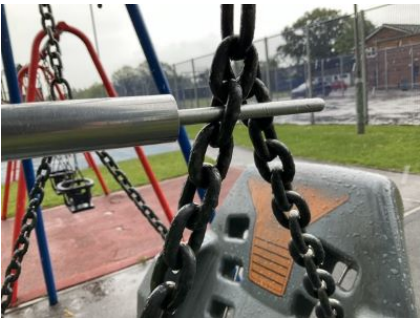
1. Shrinkage / separation of the surface. This may give a trip hazard.
2. There is wear in the bushes.
3. Loose swing seat eye-bolts.

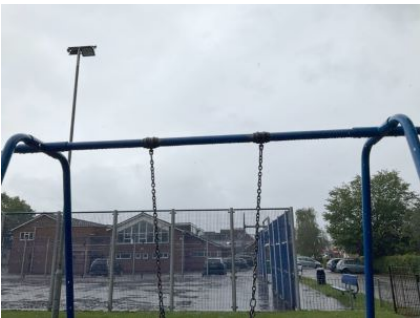
There is wear in the bushes.

Remove shackle bolt and check bush and shackle pin wear, replacing as necessary.

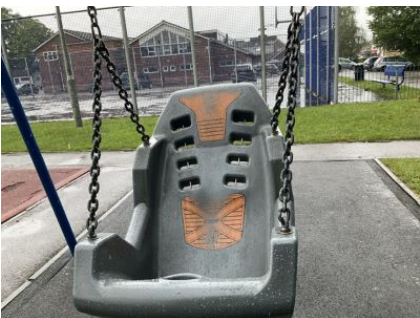
Loose swing seat eye-bolts.

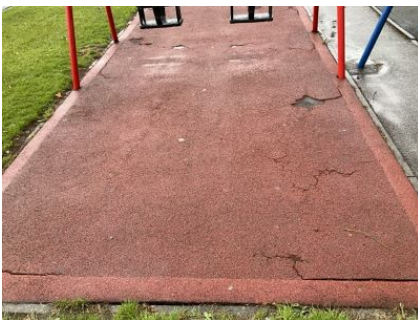
Surface needs repair.

Wet pour edges are shrinking, cracking and lifting, creating a potential trip point/ankle turn. Along with holes forming. Repair.

Re-glue and fill gaps and joints as necessary., Repair.

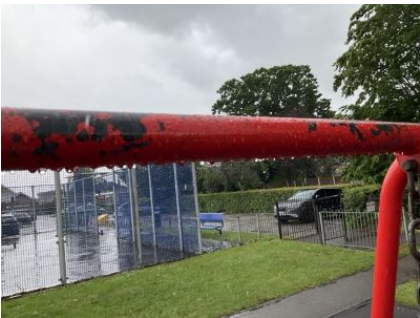
Paintwork is in poor condition.

De-scale back to good base material and coat with lead free paint, using appropriate precautions. Repairs may be necessary where corrosion is severe.

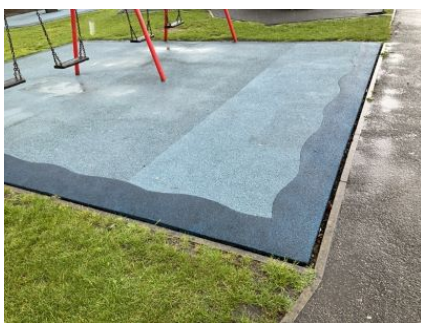
Shrinkage / separation of the surface. This may give a trip hazard.

Wet pour edges are shrinking and lifting, creating a potential trip point/ankle turn. Repair.

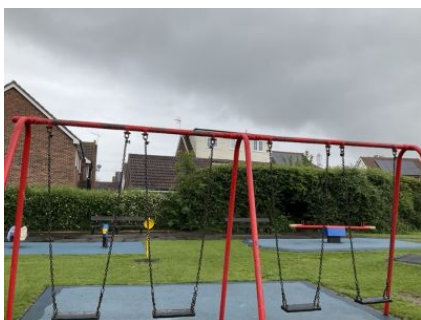
There is wear in the bushes.

Several bushes are wearing. Replace in the near future.

Remove shackle bolt and check bush and shackle pin wear, replacing as necessary.

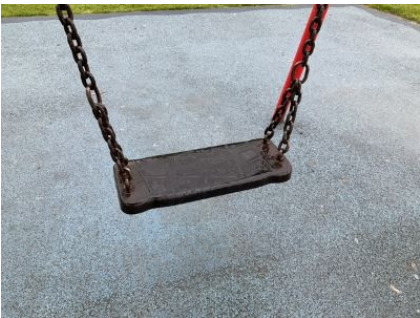
Loose swing seat eye-bolts.

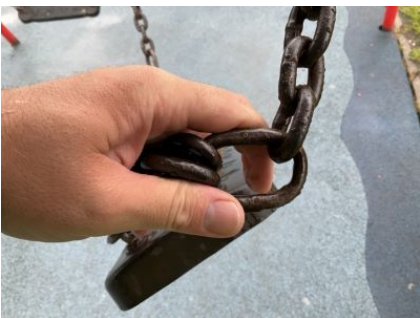
Some chain wear.

Monitor for further deterioration and replace before 40% wear.

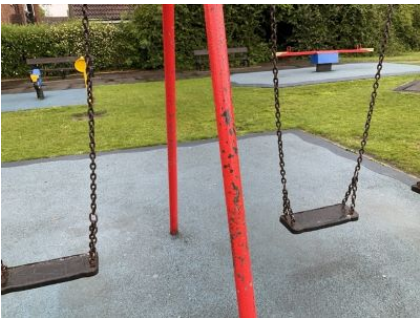
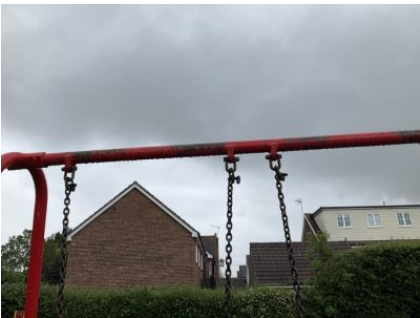
Paintwork is in poor condition.

De-scale back to good base material and coat with lead free paint, using appropriate precautions. Repairs may be necessary where corrosion is severe.

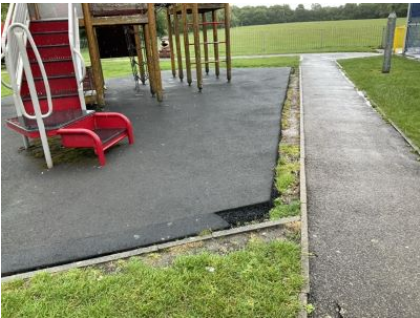
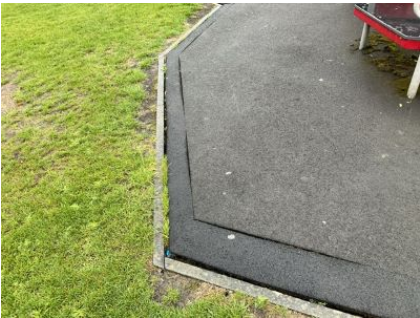
Surface needs repair.

There is damage to surfacing and shrinkage, repair.

Repair.

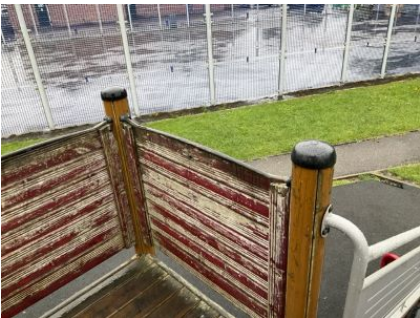
Minor repairs are needed.

Repair.

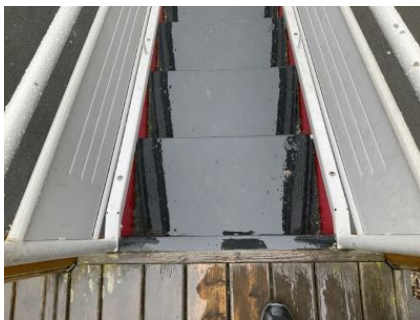
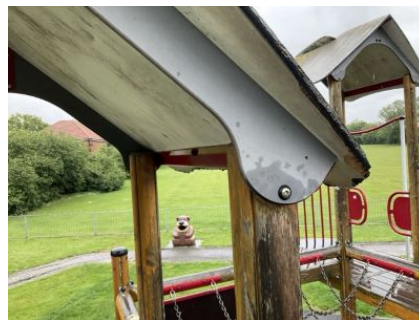
Bolt(s) loose.

Access step frames are loose to multiplay.  
Roof bolts are slightly loose.

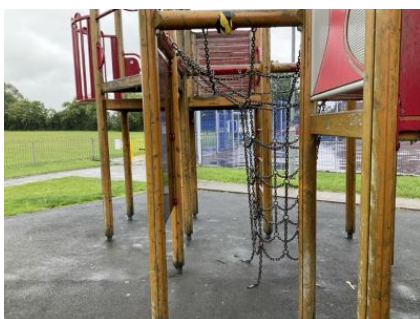
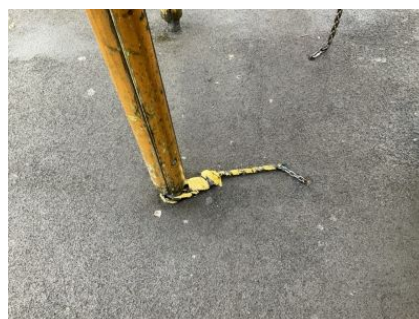
Item is damaged.

Button seat/climbing element is now broken and taped up to unit. Replace.

Replace.

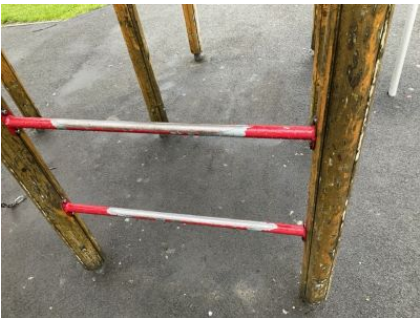
Paintwork is in poor condition.

De-scale back to good base material and coat with lead free paint, using appropriate precautions. Repairs may be necessary where corrosion is severe.

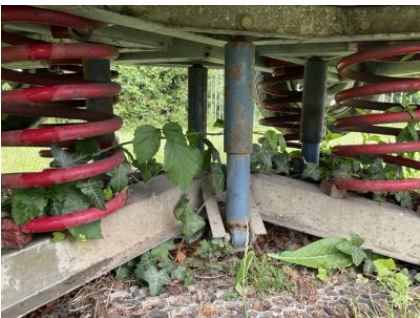
The spring is rusty. These have been known to fail without warning, leading to a collapse of the unit.

Early signs of rusting on spring and suspension.

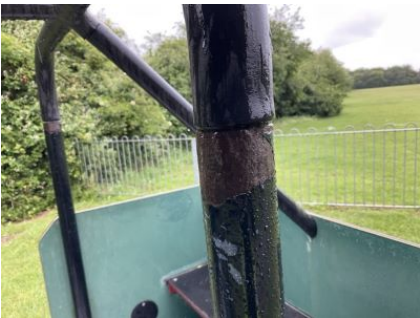
Paintwork is in poor condition.

De-scale back to good base material and coat with lead free paint, using appropriate precautions. Repairs may be necessary where corrosion is severe.

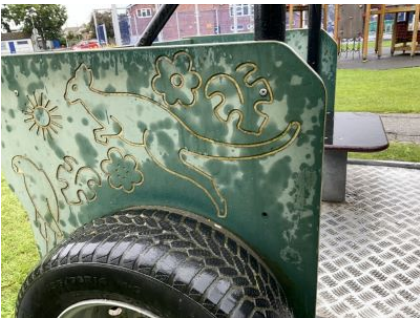
Fixtures loose or missing.

Panel fixture is missing.

Replace.

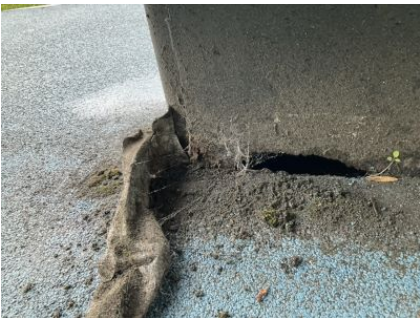
Item has corrosion.

Tape is no longer sticking; was used to cover corrosion. Remove and treat areas as holes are present.

Replace.

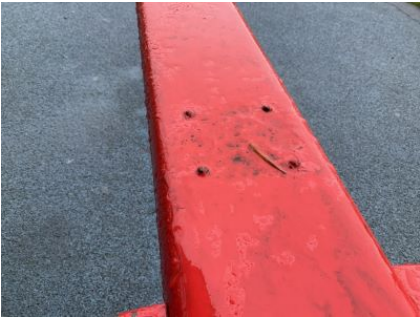
Manufacturer plaque. Repair.

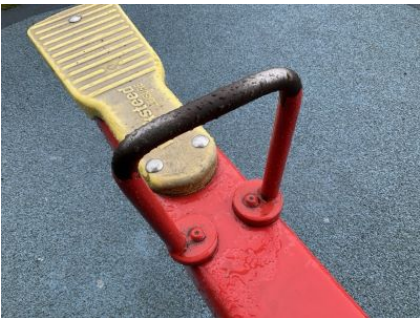
Paintwork is in poor condition.

De-scale back to good base material and coat with lead free paint, using appropriate precautions. Repairs may be necessary where corrosion is severe.
