Safety Inspection Report

Annual Inspection

Hullbridge Road

South Woodham Ferrers Town Council

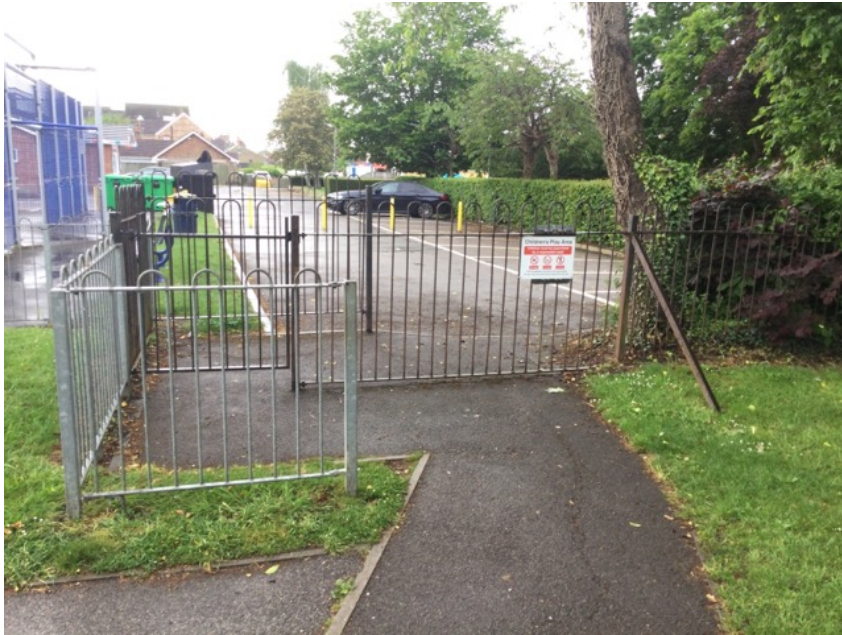
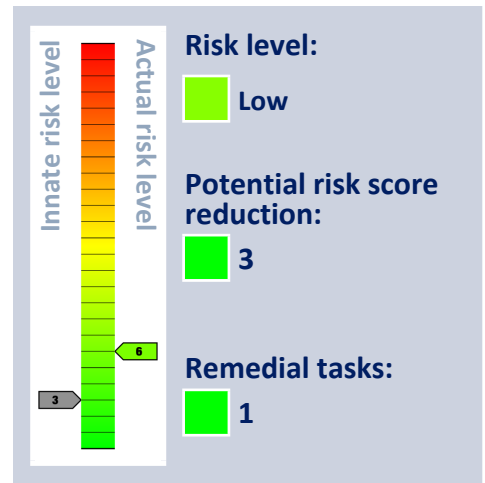
Fencing - Bow-Top

There is a neck entrapment in the top of the fence. Whilst fences are not playground equipment, the CEN technical report CEN/TR 16879:2016, clause 4.3.4 advises that fencing close to playgrounds should comply with the entrapment requirements of EN 1176-1.

No reasonably practicable action is identified.

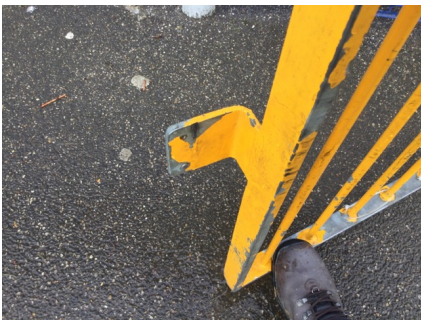
Gates - Pedestrian

Gate buffer(s) required.

Fit a buffer.

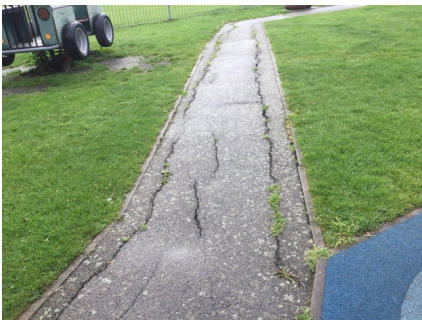
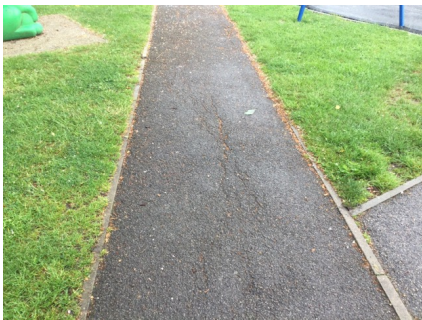
Pathways - Internal

The surface is cracking.

Repair.

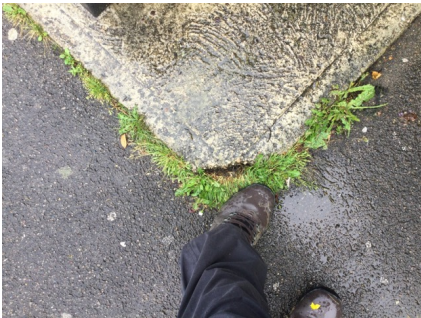
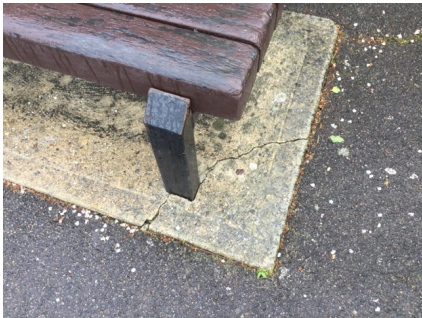
Seating - Benches x 2

Description
Concrete edges are in poor condition.
Tasks
Repair.
Note
Damaged and cracked.

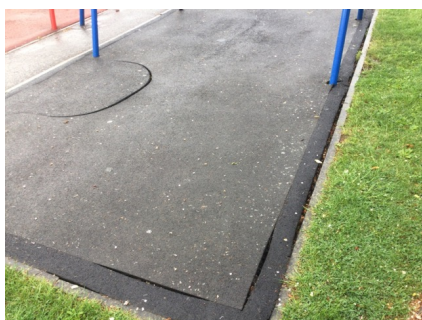
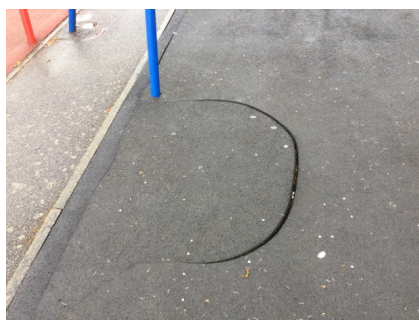
Swing - Accessible - 1 Bay 1 Seat

Shrinkage / separation of the surface. This may give a trip hazard.

Re-glue and fill gaps and joints as necessary.

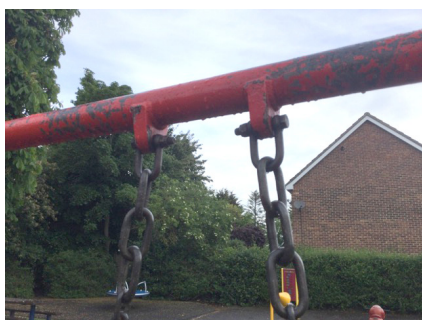
Swing - Toddler - 1 Bay 2 Seat

There is wear in the bushes.

Remove shackle bolt and check bush and shackle pin wear, replacing as necessary.

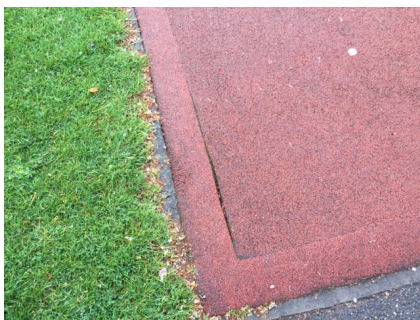
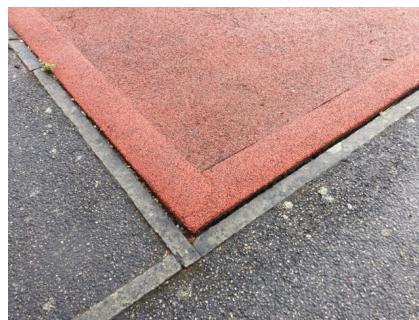
Shrinkage / separation of the surface. This may give a trip hazard.

Edge separating and rising causing a trip hazard.

Re-glue and fill gaps and joints as necessary.

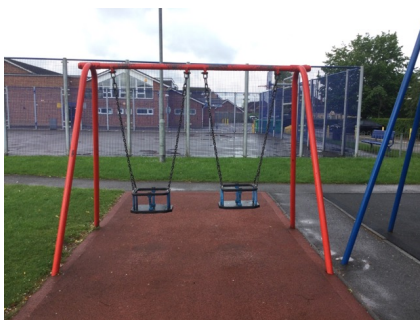
The dimension between adjacent swing seats is less than permitted.

The unit was installed prior to the publication of the current standards. There is no requirement to make retrospective changes.

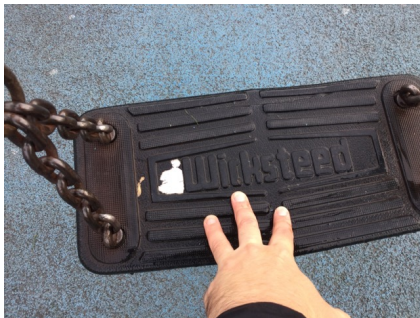
Swing - Belt - 2 Bay 2 Seat

The swing seat has been damaged, but does not require immediate replacement.

Monitor and replace when hard material is exposed.

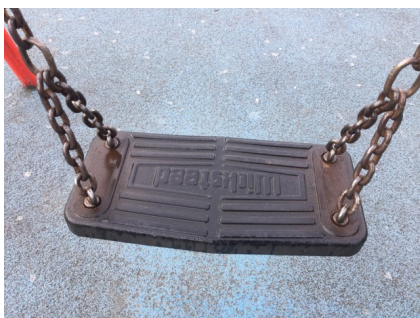
Loose swing seat eye-bolts.

Tighten connecting nuts.

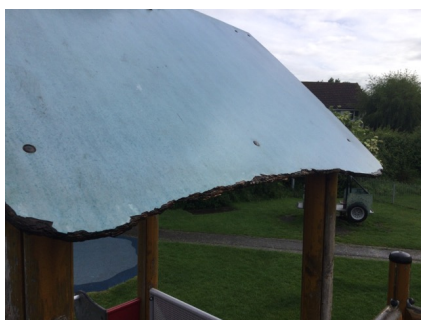
Multiplay

Roof panel is damaged.

There is an onset of rot in this damage. Replace.

Replace.

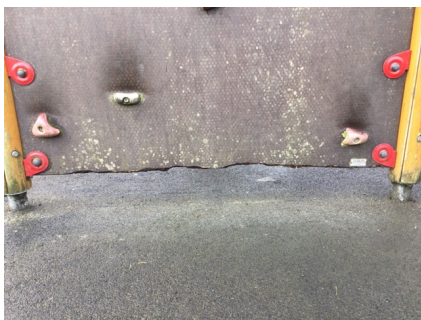
Delamination of wood.

Climbing wall base.

Repair.

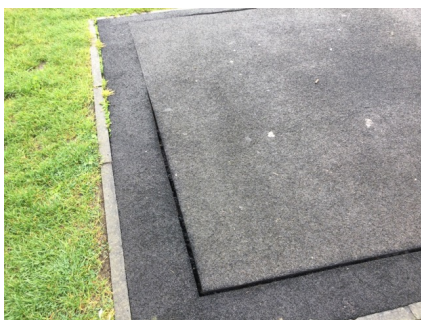
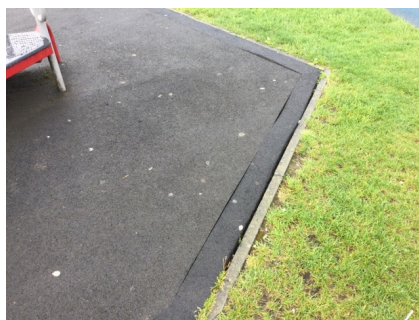
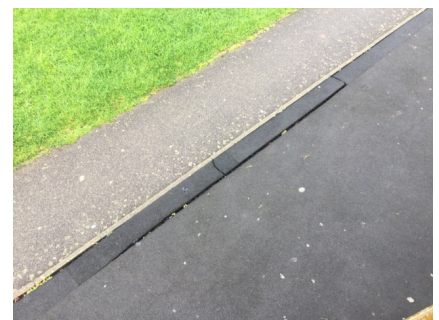
Shrinkage / separation of the surface. This may give a trip hazard.

Re-glue and fill gaps and joints as necessary.

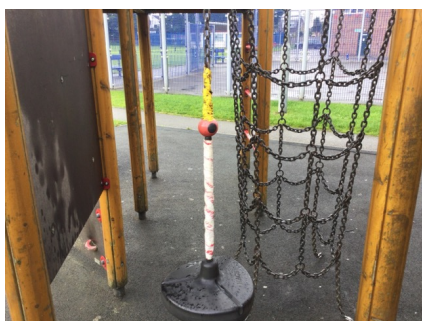
Item is damaged.

The chain cover is damaged and has been repaired with tape - unable to gauge the level of damage due to tape.

Monitor and replace when necessary.

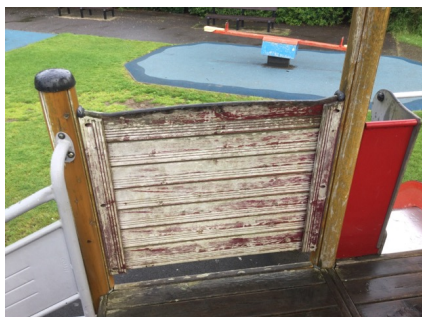
Paintwork is in poor condition.

De-scale back to good base material and coat with lead free paint, using appropriate precautions. Repairs may be necessary where corrosion is severe.

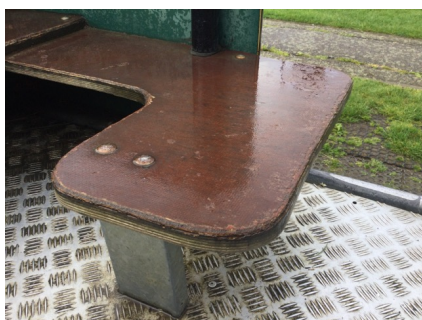
Rocker Jeep

Laminate damaged.

Rub down and treat damaged edges.

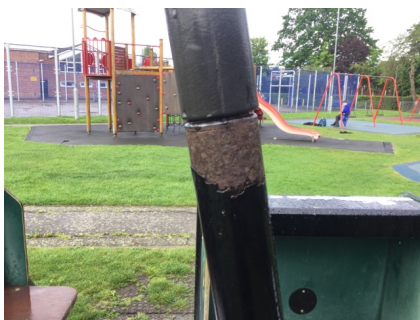
Paintwork is in poor condition.

Frame.

De-scale back to good base material and coat with lead free paint, using appropriate precautions. Repairs may be necessary where corrosion is severe.

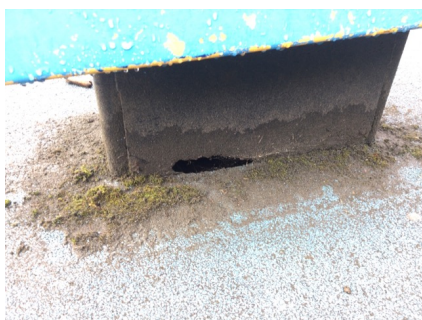
Rocker - Seesaw

Item has corrosion.

Side panel.

Replace.

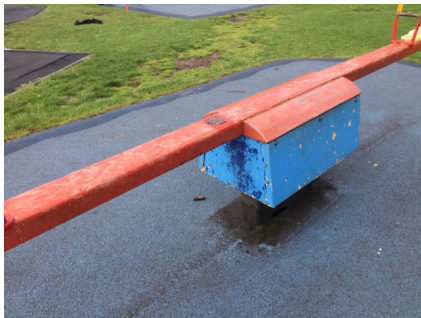
Paintwork is in poor condition.

De-scale back to good base material and coat with lead free paint, using appropriate precautions. Repairs may be necessary where corrosion is severe.

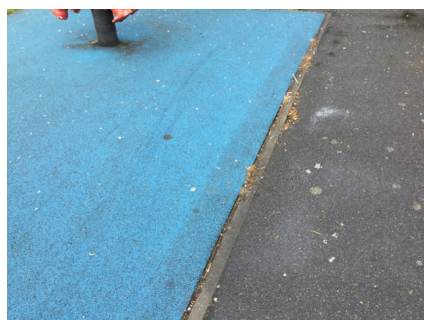
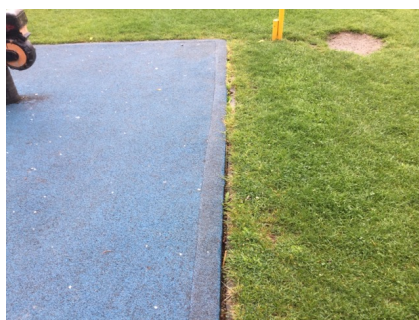
Rocker Hedgehog - Sit-In

Shrinkage / separation of the surface. This may give a trip hazard.

- Finding is for all of the rockers wet pour.

Re-glue and fill gaps and joints as necessary.

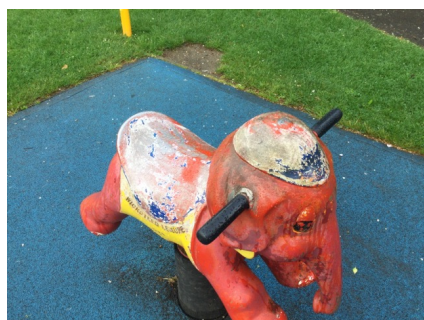
Rocker - Elephant

Paintwork is in poor condition.

De-scale back to good base material and coat with lead free paint, using appropriate precautions. Repairs may be necessary where corrosion is severe.

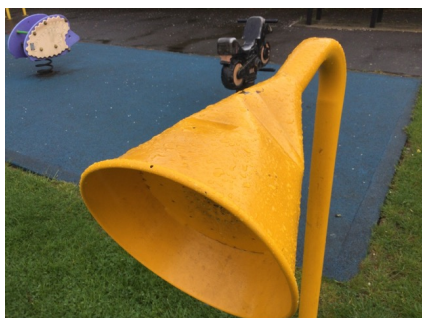
Talk Tubes

Dented. Monitor.
Worn ground areas. Repair.

Monitor., Repair.

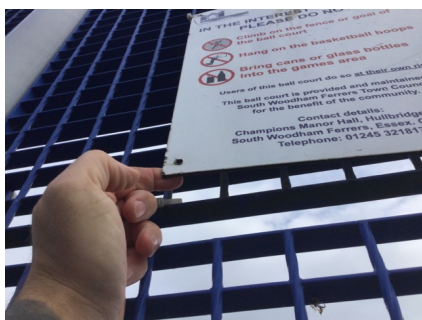
MUGA

Signage is missing x1 fixing Repair.

Repair.
