# Safety Inspection Report

Annual Inspection

## Hullbridge Road

Site name: **Hullbridge Road**  
Date of inspection: **20 May 2025**  
Inspector: **Craig Owen**  
[w3w.co/replying.cursing.inflamed](https://w3w.co/replying.cursing.inflamed)

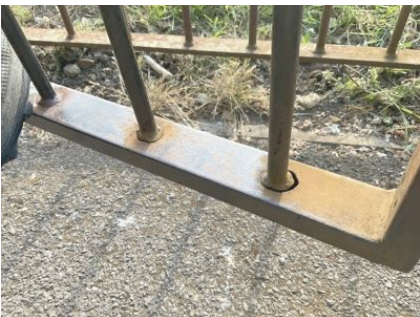
| Welds are cracked. |
| Welds are cracked on the base of brown gate. |

| Repair. |

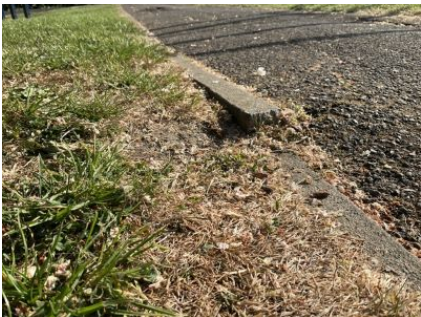
| Description |
|---|
| The surface is cracking. |
| Tree root damage to the path, leaving a trip hazard. |

Surface needs repair.

| Description |
|---|
| Repair. |

Repair.

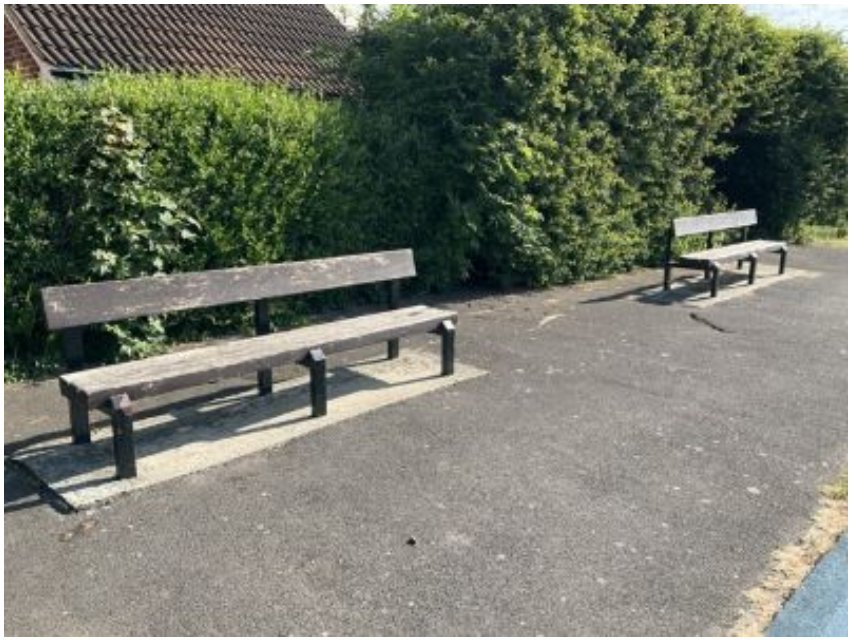
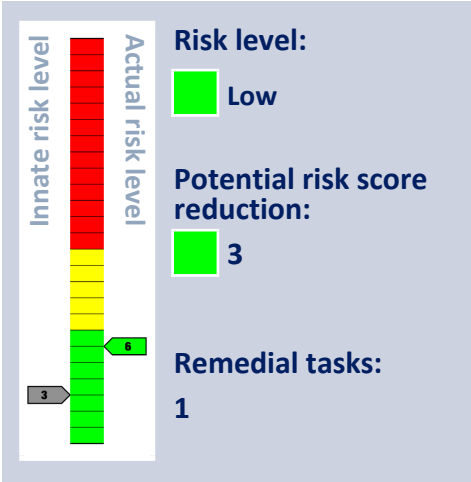
# Seating - Benches x 2

| Description |
|---|
| Concrete edges are in poor condition. |
| Damaged and cracked. |

| Description |
|---|
| Repair. |

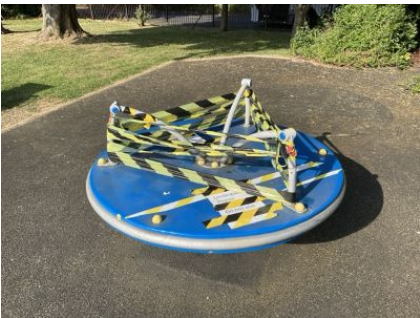
Fixtures loose or missing.

Underside carousel platform is loose, creating a potential finger pinch/pinch point.  
Secure.

The bearings have worn.

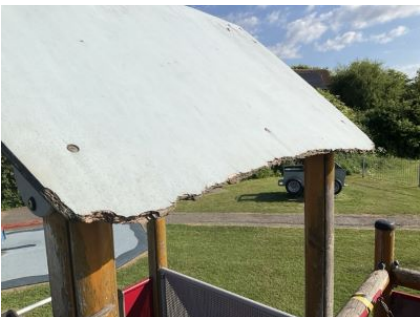
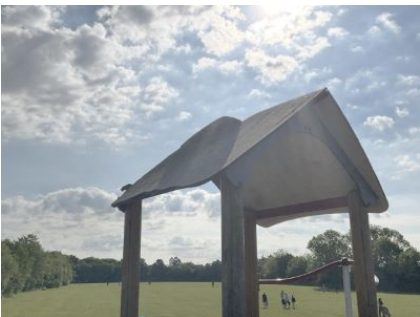
Roof panel is damaged.

There is an onset of rot on both roof panels. Replace.

Replace.

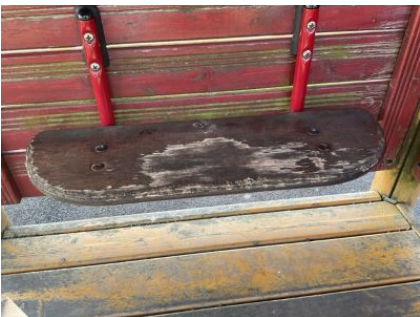
Laminate damaged.

Rub down and treat damaged edges.

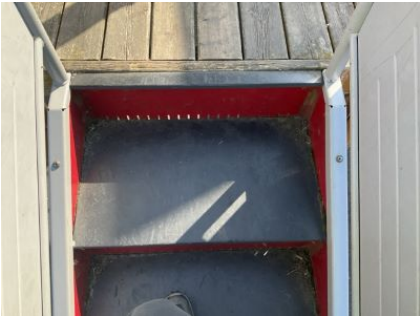
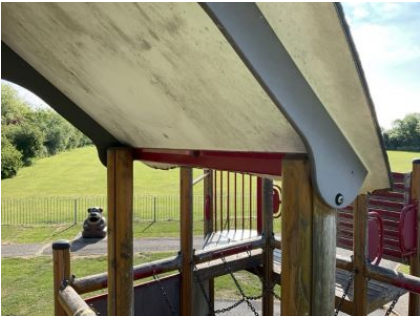
Bolt(s) loose.

Access step frames are loose to multiplay.  
Roof bolts are slightly loose.

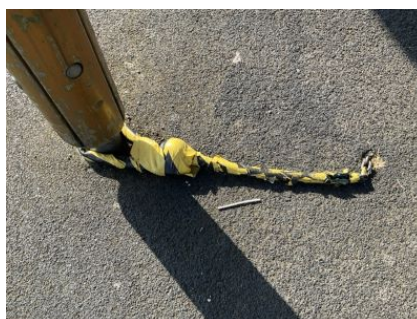
Item is damaged.

Button seat/climbing element is now broken and tapped up to unit. Replace.

Replace.

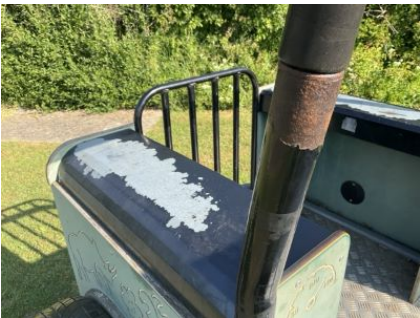
Paintwork is in poor condition.

De-scale back to good base material and coat with lead free paint, using appropriate precautions. Repairs may be necessary where corrosion is severe.

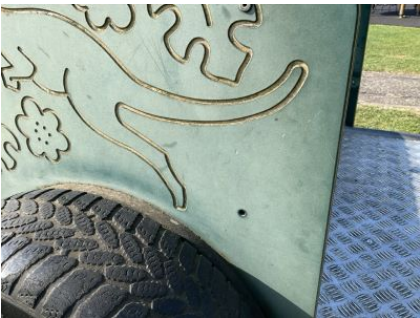
Fixtures loose or missing.

Panel fixture is missing.

Replace.

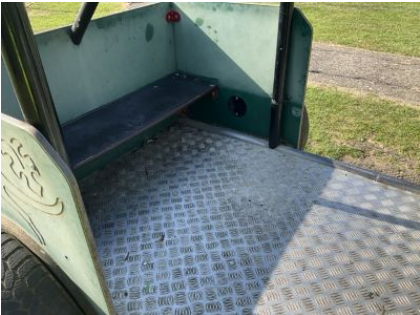
Item has some parts missing.

Bench x 1 is missing. Replace.

Replace the missing parts.

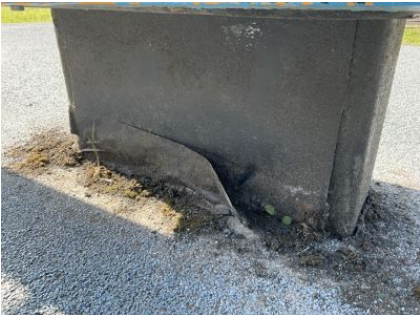
Item has corrosion.

Side panel has been taped over covering corrosion. Remove and treat areas.

Replace.

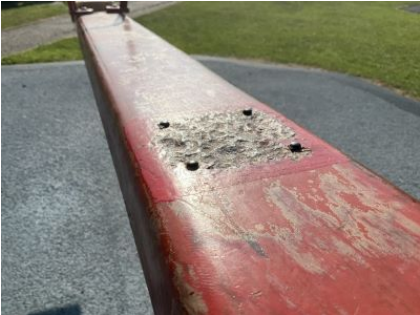
Manufacturer plaque. Repair.

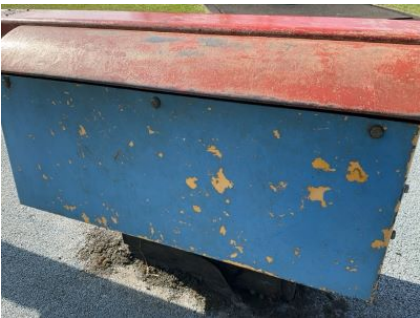
Paintwork is in poor condition.

De-scale back to good base material and coat with lead free paint, using appropriate precautions. Repairs may be necessary where corrosion is severe.

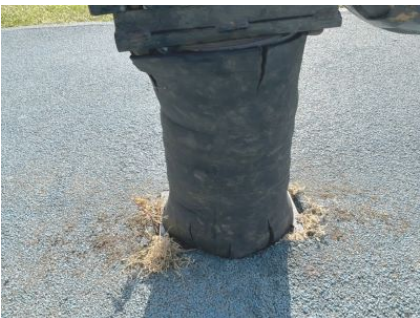
Missing / damaged spring cover.

Replace when necessary.

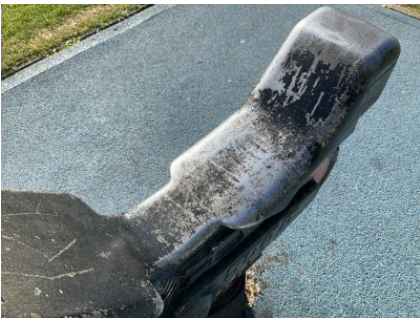
Paintwork is in poor condition.

De-scale back to good base material and coat with lead free paint, using appropriate precautions. Repairs may be necessary where corrosion is severe.

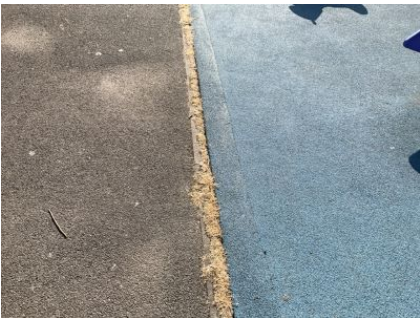
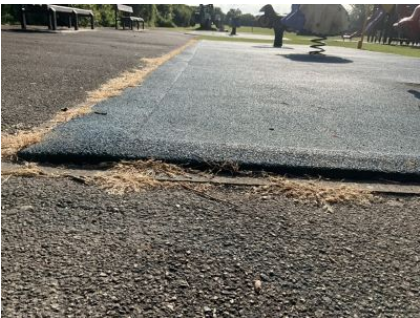
Shrinkage / separation of the surface. This may give a trip hazard.

Finding is for all of the rocker wet pour.  
Wet pour edges are shrinking and lifting, creating a potential trip point/ankle turn.  
Remove weeds and repair.

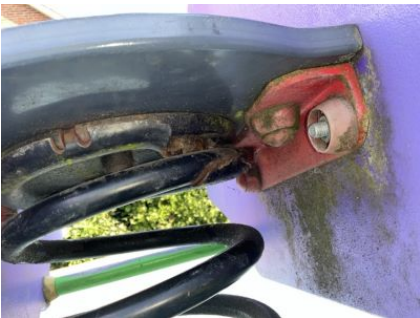
The spring is rusty. These have been known to fail without warning, leading to a collapse of the unit.

Early signs of rusting on spring.

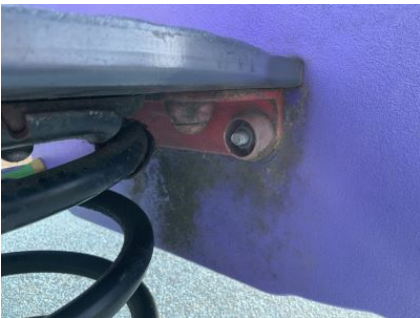
Cap missing.

Replace.

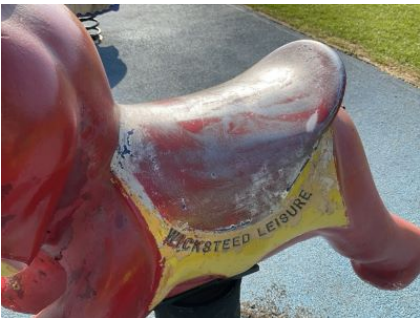
Paintwork is in poor condition.

De-scale back to good base material and coat with lead free paint, using appropriate precautions. Repairs may be necessary where corrosion is severe.

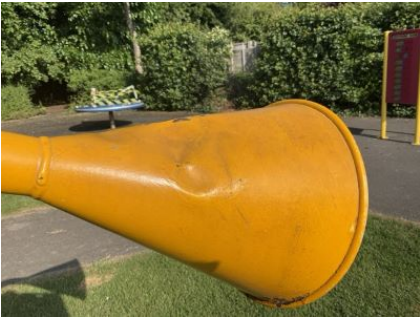
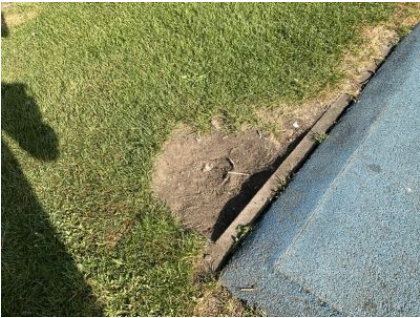
Additional comments are noted below.

Dented. Monitor.  
Chipped paint. Repaint.  
Worn ground areas. Repair.

Monitor., Repair.

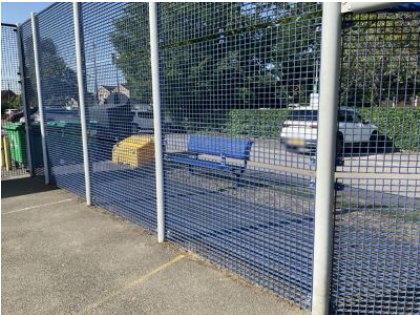
Bolt(s) loose.

Various fixtures are loose. Tighten all loose fixings.
