# Safety Inspection Report

Annual Inspection

## Hullbridge Road

South Woodham Ferrers Town Council

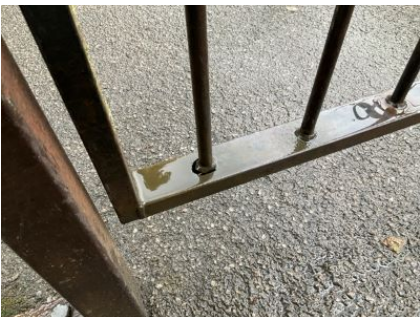
| Description |
|---|
| Welds are cracked. |
| Welds are cracked on the base of brown gate. |

| Description |
|---|
| Repair. |

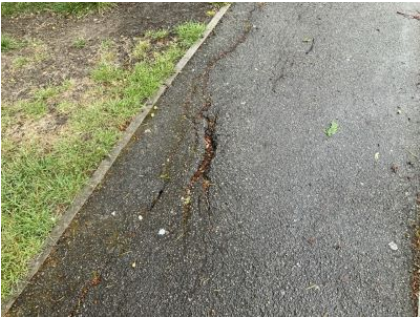
Surface needs repair.

Brick work at field entrance is poor. Repair.  
Raised poles around pathway (near bear bin and jeep). Repair.

Repair.

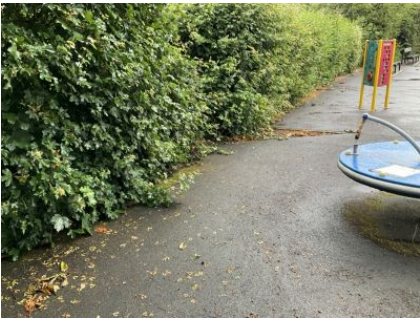
Surface needs repair.

Wet pour edges are shrinking and lifting, creating a potential trip point/ankle turn.  
Repair.  
Cracking and worn areas. Repair.

Re-glue and fill gaps and joints as necessary., Repair.

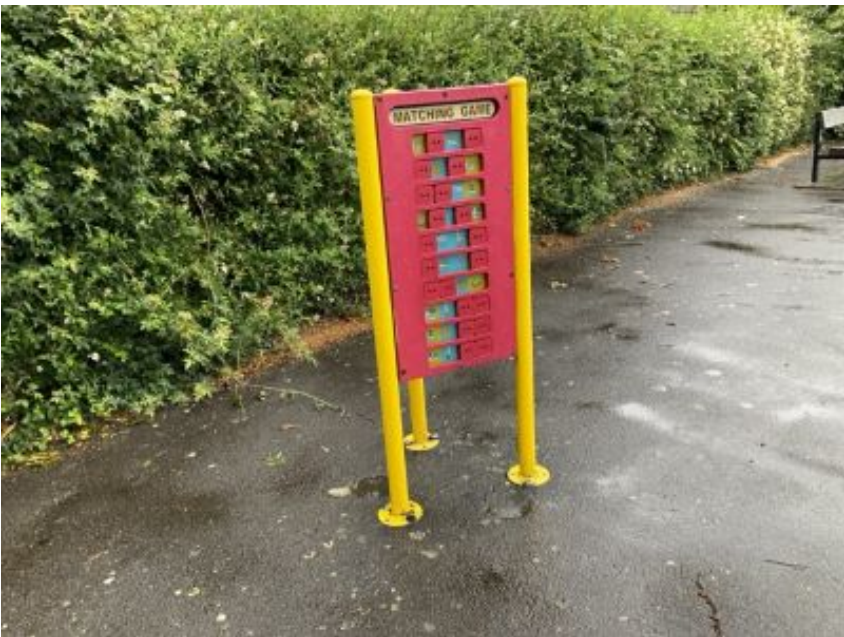
Bolt(s) loose.

Foundation bolts are loosening. Monitor and repair when necessary.

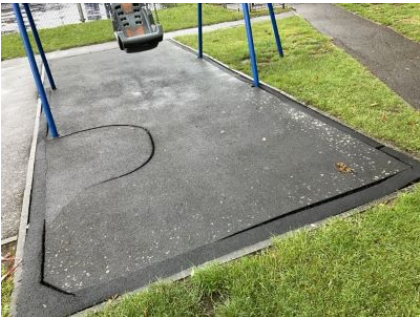
Shrinkage / separation of the surface. This may give a trip hazard.

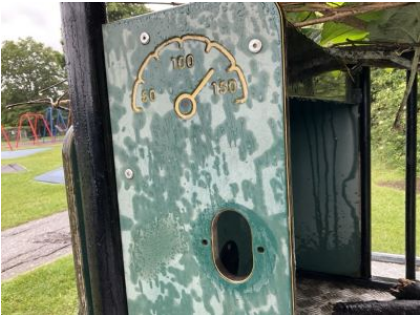
Item has corrosion.

Tape is no longer sticking; was used to cover corrosion. Remove and treat areas as holes are present.

Replace.

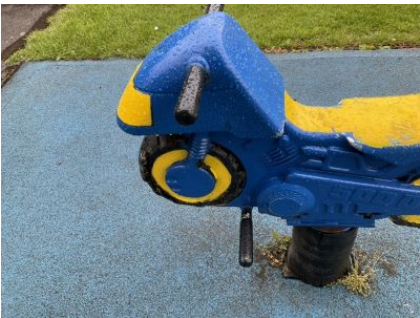
- The item has the following maintenance findings:
1. Missing / damaged spring cover.

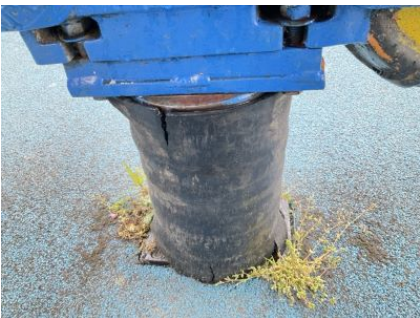
Missing / damaged spring cover.

Replace when necessary.

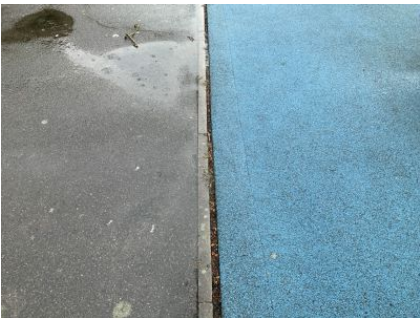
Shrinkage / separation of the surface. This may give a trip hazard.

Finding is for all of the rocker wet pour.  
Wet pour edges are shrinking and lifting, creating a potential trip point/ankle turn.  
Remove weeds and repair.

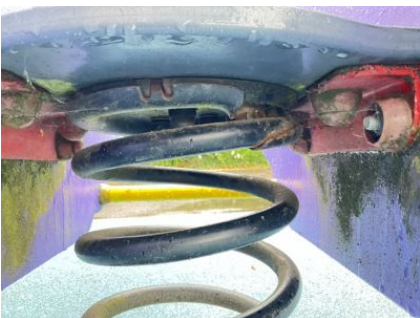
The spring is rusty. These have been known to fail without warning, leading to a collapse of the unit.

Early signs of rusting on spring.

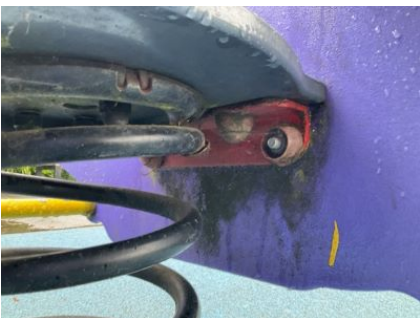
Cap missing.

Replace.

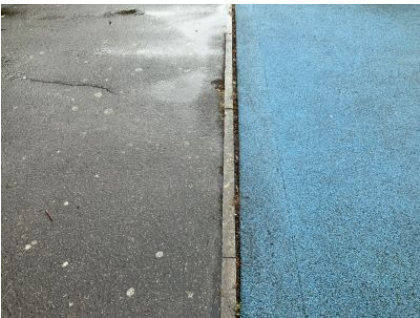
Shrinkage / separation of the surface. This may give a trip hazard.

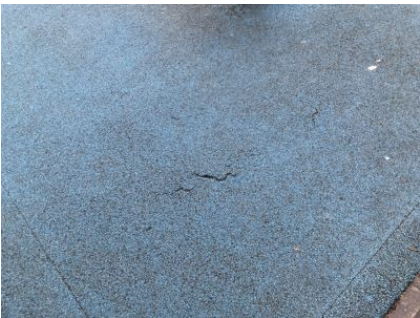
The surface is cracking.

Repair.

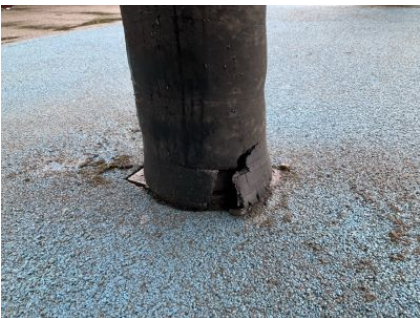
Missing / damaged spring cover.

Replace.

Replace when necessary.

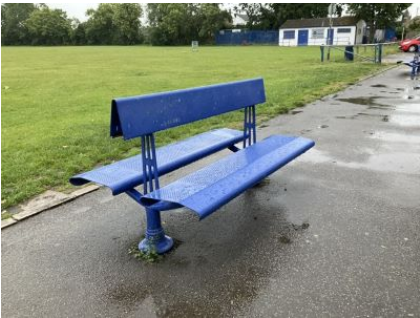
Bolt(s) loose.

Muga benches are loose to surface. Repair.

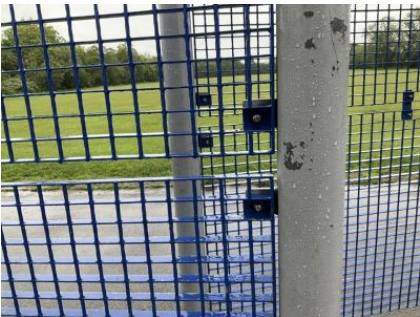
Bolt(s) loose.

Various fixtures are loose. Tighten all loose fixings.

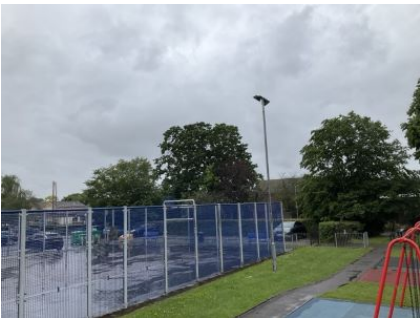
Electrical equipment is outside the scope of this inspection. It should be inspected by a competent person as recommended by the manufacturer.
